PHOTOGRAPHIC INTERPRETATION REPORT

MISSILE DEVELOPMENT AND PRODUCTION CENTER AT DNEPROPETROVSK, USSR DECEMBER 1963

NPIC/R-250/64 - April 1964

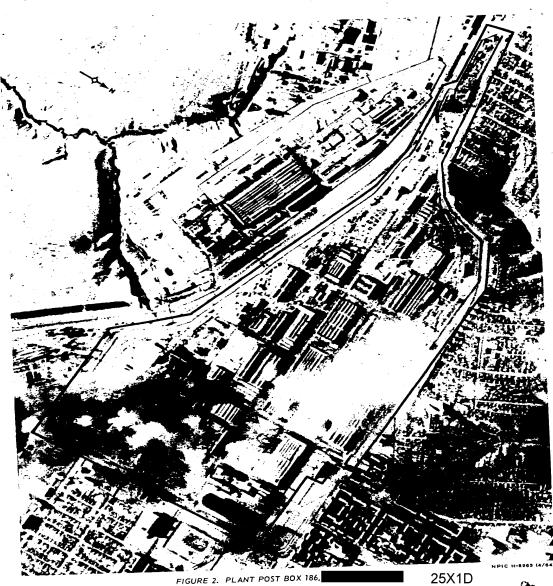
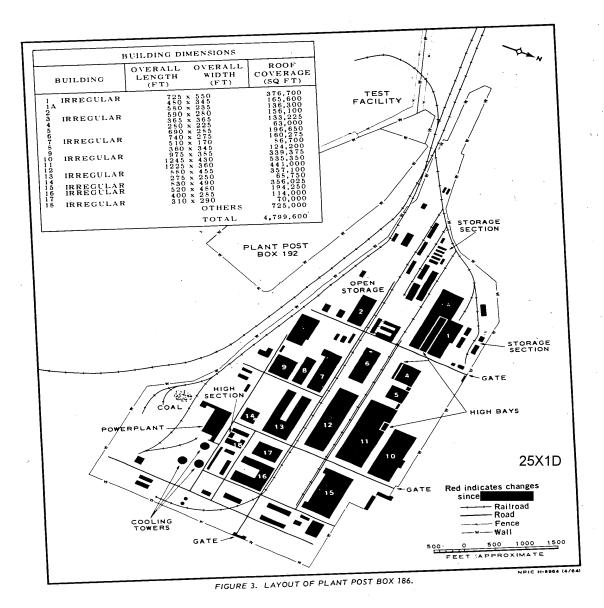
Plant Post Box 186 constitutes the major part of the Dnepropetrovsk Missile Development and Production Center and accounts for about half of the total acreage of the installation (Figures 2 and 3). This facility con-

tains a powerplant, 18 major production buildings, and numerous smaller administration, storage, and miscellaneous structures. A rail spur enters the plant area from the west, and branches of this spur serve most of the build-

Another change since _____ is the construction of an addition (item 1A, Figure 3) to the large final assembly building (item 1) in the western part of the area. This addition measures approximately 480 by 345 feet, and the 165,600 square feet of added roof coverage represents an increase of more than 40 percent in the roof coverage of the final assembly building. Construction began on this addition some time after

the addition appeared to be nearing completion with some work possibly remaining to be done on the roof. One monitor is evident on the northern end of the roof, and other monitors will probably be constructed on the remaining portion.

A third significant change is the construction of a production building (item 3), measuring 590 by 280 feet, in the southern portion of the plant area. A small patch of light-toned earth scarring seen at the site on photography of may have represented initial construction efforts. Photography of revealed the rectangular outline of the foundation, and photography revealed the structure nearing completion. Its roof structure consists of two rows of three wide monitors, parallel to the long axis of the building. The outside roof edges appeared indefinite, indicating that construction may be incomplete.

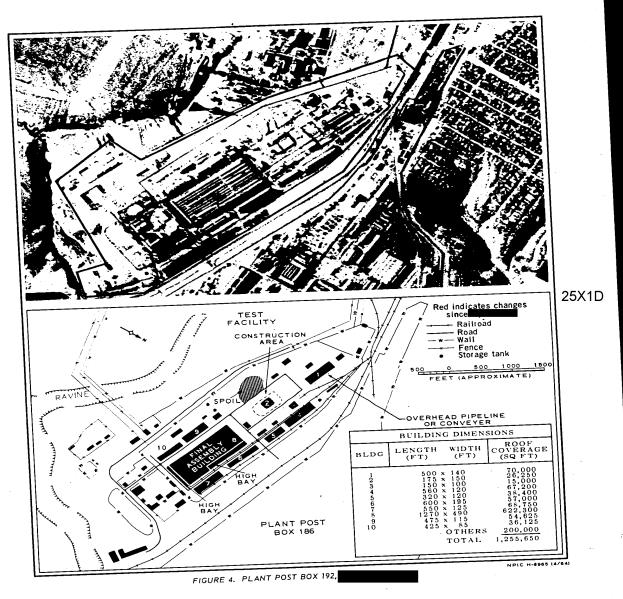
Plant Post Box 192 is located between Plant Post Box 186 and the Test Facility along the south side of the main rail line running through the complex (Figure 4). The main part of this area is walled and contains one large final assembly building (item 8, Figure 4) and seven smaller production buildings. A contiguous walled/fenced area on the southeast contains one small industrial building

A production building (item 4) has been added in the northern part of the plant. This building has also been constructed since

Photography of which was very hazy, revealed this building in the mid stage of construction. On photography, it appeared complete, although the indistinct edges of what appeared to be two monitors extending the length of the roof indicated that some work remained to be done.

In a building was under construction (item 2) west of the large final assembly building (item 8). The excavation for this structure had been started when the plant was first seen on photography of Photography from subsequent missions

revealed steady progress; spoil from the large hole was being piled across the road to the south. By a rectangular building foundation rising slightly above ground level was visible in the center of the excavation. Additional excavation and construction were also evident in a larger rectangular area surrounding the foundation.

A small gable-roofed storage building (item 3) has also been constructed in the same area since Buildings added since or presently under construction add more than 110,000 square feet to the plant, resulting in a total roof coverage of 1,255,650 square feet.

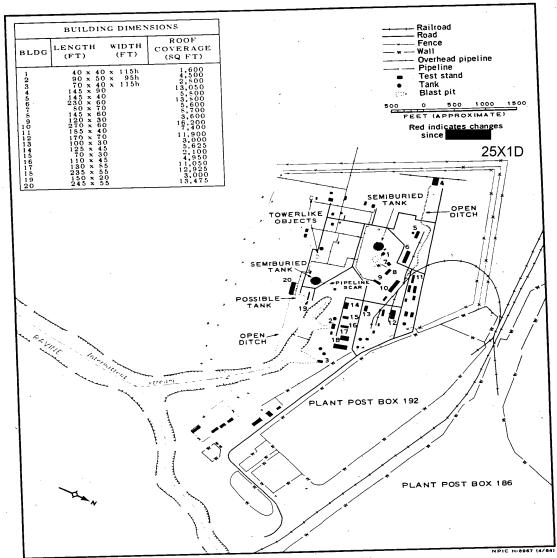
FIGURE 6. LAYOUT OF TEST FACILITY.

The DMDPC Test Facility is located immediately west of Plant Post Box 192 (Figures 5 and 6). It is surrounded by a triple security fence and appears to have little direct road access to the other two areas of the plant. A rail spur enters the Test Facility from the north and serves several of the buildings, but does not appear to extend to any of the test stands. The major components of the facility consist of three large vertical test stands (items 1, 2, and 3, Figure 6) and numerous support structures in the northern half of the area and a number of smaller structures connected by a system of overhead pipelines in the southern half.

at one stand (item 3) is cone shaped with the apex of the cone appearing to center on the stand. This would indicate that the stand has a single test position. The mark at the other stand (item 2) is irregular in shape and appears to have emanated from one side of the stand rather than from the center; this indicates the presence of more than one test position. No

construction or development has taken place in the newly enclosed area. Second, a large rectangular structure (item 4), measuring 145 by 90 feet, has been constructed at a relatively isolated site on the western edge of the test area. Indications that this structure may still be under construction are that it is difficult to determine the shape of the roof and that an open ditch extends from the structure to a building (item 10) in the center of the facility. Overhead pipelines of undetermined function appear to extend from the roof of this structure, downward to the ground to the north and south. These pipelines extend for short distances and have indefinite terminal points; this also suggests incomplete construction and/ or intended further extension. A shallow excavation extends beyond the building on the south and southwest.

The system of overhead pipelines connects most of the structures in the northern half of the test area. Only one of the pipelines is seen near the test stands; this line appears to connect to a building (item 9) between two test stands (items 1 and 2). The locations of

other terminal points of the pipelines system are vague. One pipeline extends beyond the triple fence on the western side of the facility; another appears to go underground between the outer and inner fences on the south; one enters a long, low structure (item 20) in four distributaries; and others branch out to groups of small structures. The function of these

A long, low structure (item 20) in the south-central part of the facility was seen more clearly on the photography. It has indefinite, somewhat rounded edges which may indicate bunkering. Lines of the overhead pipeline system were observed entering one side of this building in four places, and on the opposite side four small dark areas where snow has melted may represent the effects of one of a variety of causes such as liquid spillage, blast, or heat exhaust. An open ditch extends from the northeastern corner of the structure
